GEOLOGICAL AND GEOTECHNICAL INVESTIGATION OF EUREKA BEND, SH60, TAKAKA HILL, NEW ZEALAND

A Thesis

Bachelor of Science with Honours in Engineering Geology

2008

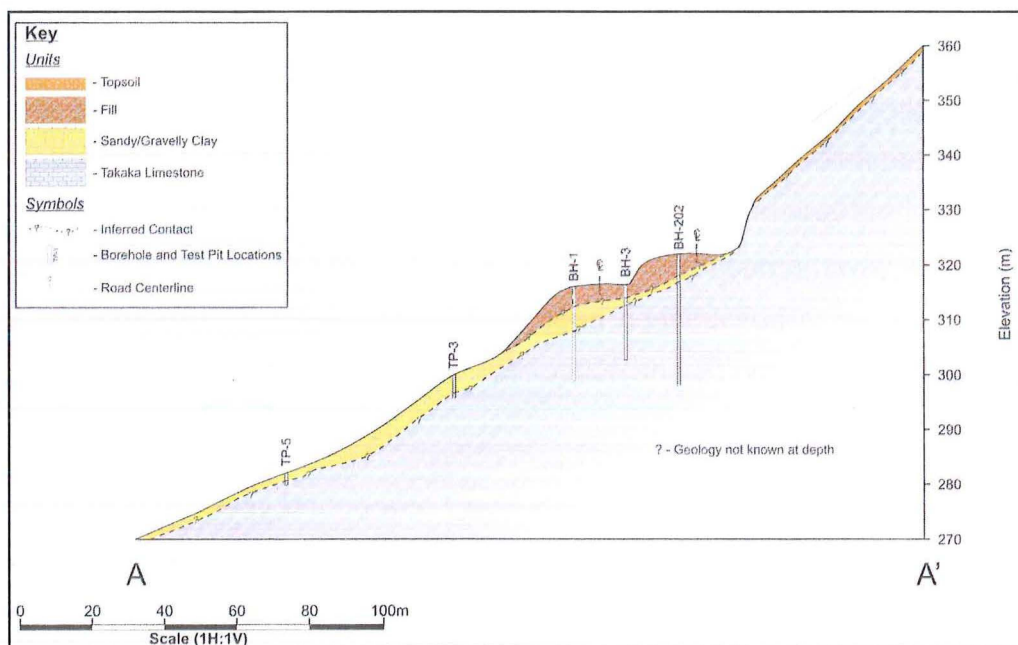
Figure 2-11: Cross-section A-A' through Eureka Bend.

Using the information discussed in Sections 2.1 and 2.2 the following cross-section (Figure 2-11) was created to provide a better understanding of the subsurface beneath Eureka Bend (location is shown in Map 2). From Figure 2-11 it is possible to see the fill makes up the first layer beneath the road surface. This overlies a sandy/gravelly clay before limestone bedrock is met at a depth of between 3.6 m and 8.3 m. From GHD's investigations it was determined that the top surface of the limestone had been subjected to erosional processes and that fresh unweathered limestone was not encountered until 14.6 m.

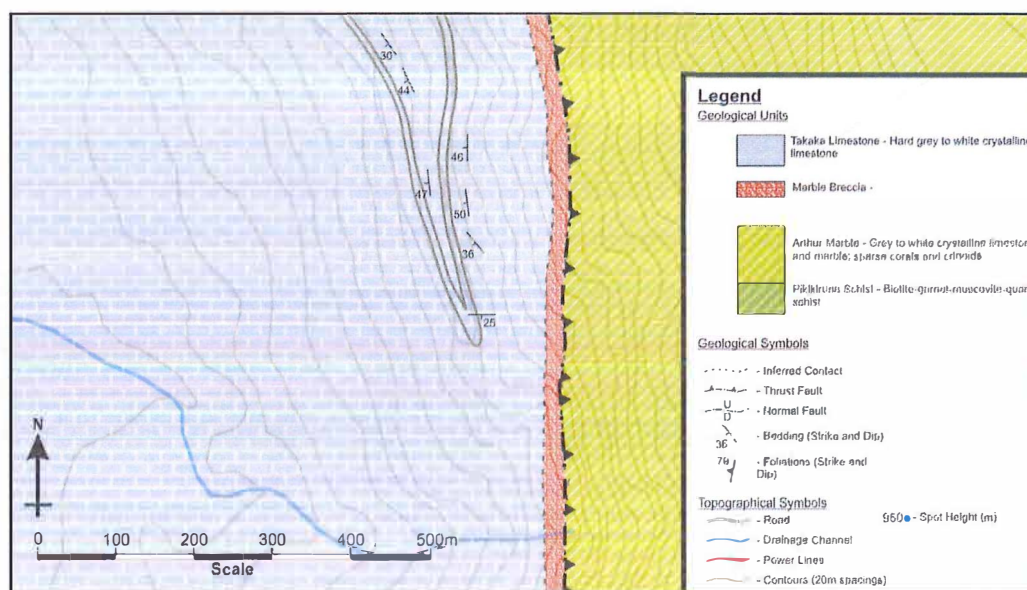
Figure 3-2: Bedding orientation adjacent to Eureka Bend.

1. The dip of the limestone beds at Eureka Bend differs from the dip of the limestone further to the north both above the upper and lower carriageways. Figure 3-2 shows how bedding adjacent to Eureka Bed dips to the south at 25°, while bedding to the north generally dips in a west to southwest orientation at 30° - 50°.
2. The presence of Arthur Marble on top of the limestone 'block'. This marble is located nearly 100 metres downslope of the in-situ marble on the up thrown side of the Pisagh Fault.

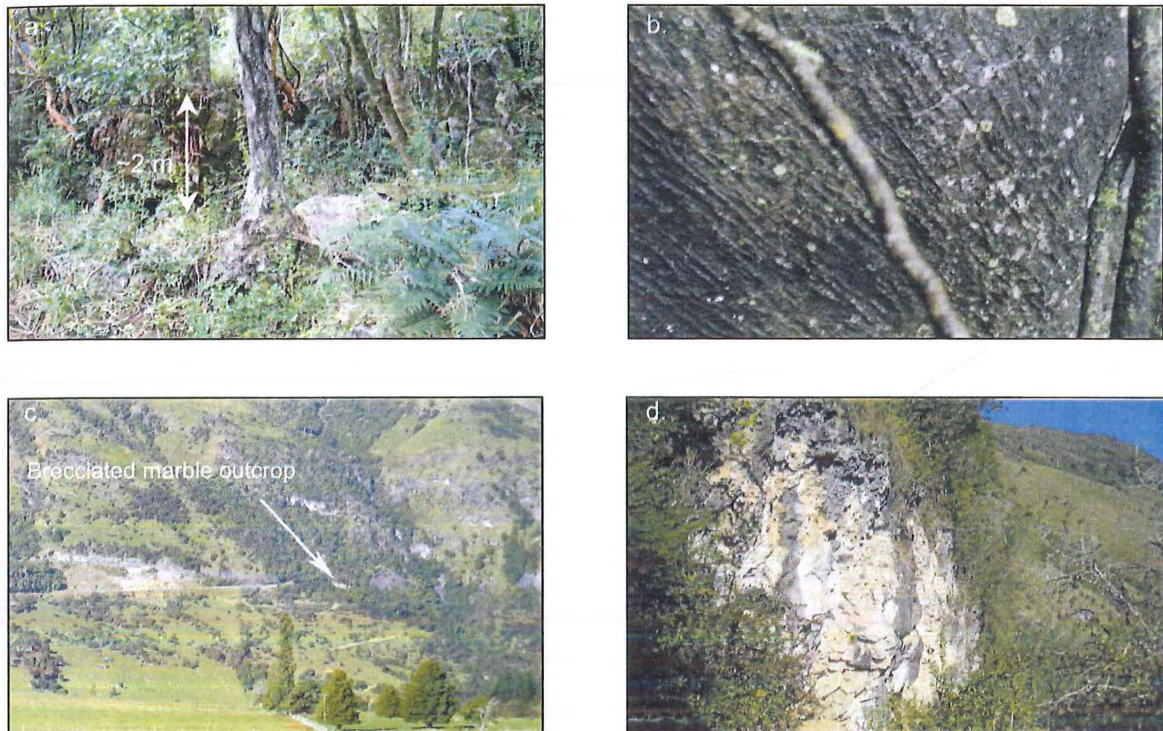
Figure 3-3: Marble step located upslope from Eureka Bend.

A thorough site inspection was conducted to determine the geology and structure of the area upslope of Eureka Bend. Arthur Marble was encountered above the road cutting at Eureka Bend in the form of two 'steps' both about 1.5 m – 2 m in height as shown in Figure 3-3a. Slickensides were observed on parts of the 'step' and are shown in Figure 3-3b. Some possible jointing was observed within the marble, however, because of a high level of degradation due to weathering it was difficult to record their orientations. Spacings of these joints were about 2 m. Brecciated material was also observed along defect planes within the marble, and examples of this can be seen in Figure 2-2b. Larger homogeneous outcrops of brecciated marble can be seen immediately to the south of Eureka Bend. They are similar in composition to the breccia seen upslope, with angular clasts of marble held in a fine-

grained calcareous matrix. It is unlikely that the breccia was formed in-situ, but it is possible that it is the result of a mass movement of Arthur Marble and fault breccia from further up slope.

a. Step in the marble. b. Slickensides on the marble. c. Location of breccia marble. d. Brecciated marble outcrop.

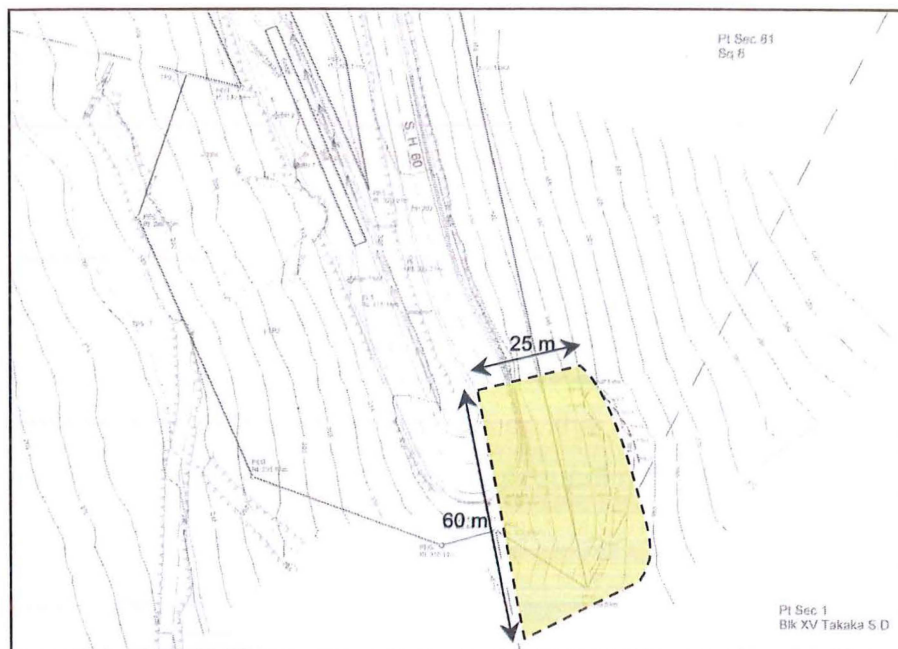
Figure 3-10: Extent of limestone block (yellow) in plan view.

From field observations the size of the block was determined to be approximately 60 m long × 25 m wide, however the depth of the block is difficult to ascertain as no

subsurface investigations have been done that provide any information in that regard. Therefore a volume cannot be accurately established. Figure 3-10 shows the extent of the block in plan view.

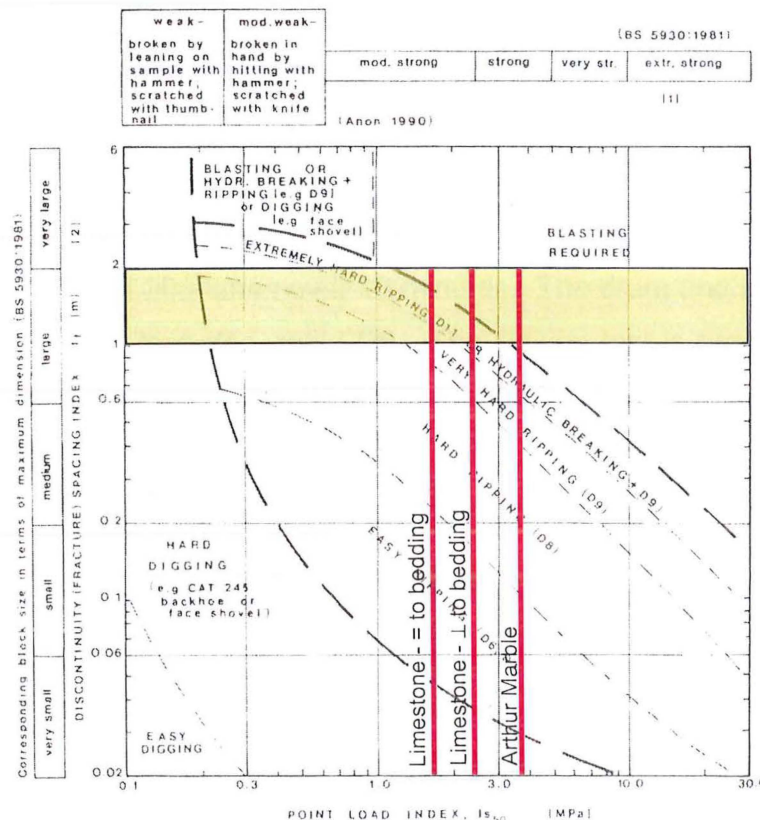
Figure 4-1: Rippability of rock as a function of mean spacings of discontinuities and compressive strength. Yellow box shows mean discontinuity spacings and red lines show point load index for each material tested (adapted from Smith, 1999).

The point load results that were obtained for the marble and the limestone have been used to determine the rippability of the materials and also their suitability as a fill material. Figure 4-1 shows the rippability of the two samples to be 'very hard' to 'blasting required' when a mean discontinuity spacing of 1 m – 2 m is used. As the excavation will be done on a near vertical face the 'perpendicular to bedding' limestone results should be used, as all excavation will occur perpendicular to the bedding. However, because of its location blasting is recommended because access for machinery is limited and all point load indices are towards the upper limit for mechanised excavation.

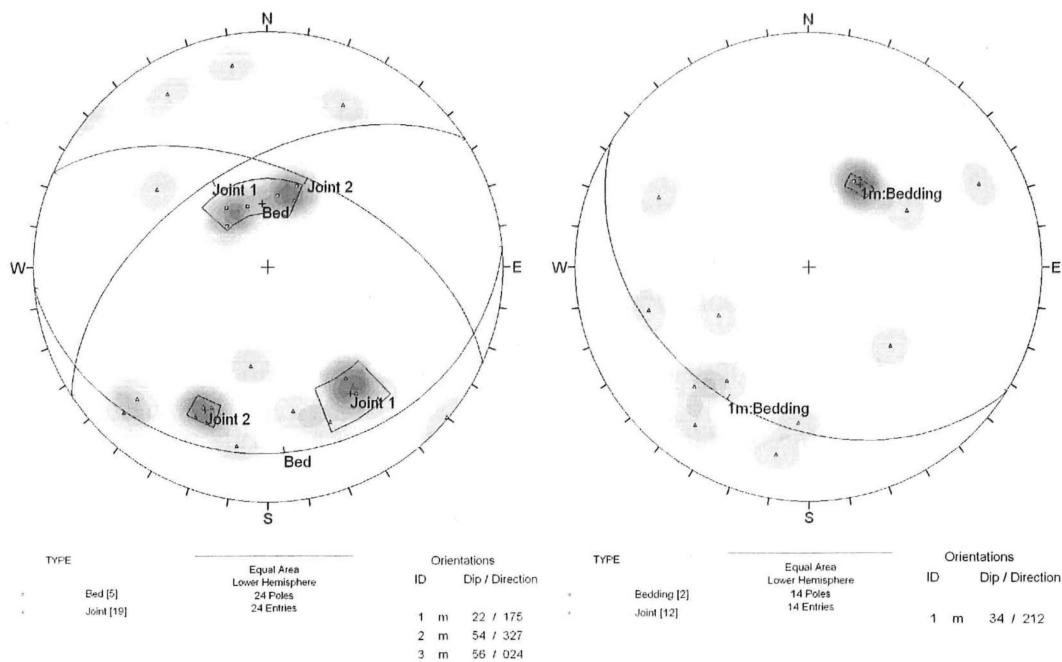
Figure 4-3: Comparison of defect data.
Left figure is my scanline data and the right is GHD's defect data.

From Figure 4-3 some correlation between the two data sets is evident, most noticeably the bedding orientation. Both sets of results show bedding that has a dip direction of south to south west which is what was expected. However, the joint sets are less reproducible as the GHD dataset is too small to create a joint set window with. Although, just from studying the two figures it is possible to see a small
